December 1, 1985

Project No. 612037

Letter Report
Transmittal of Analytical Results
Chicago Heights Steel
Chicago Heights, Illinois

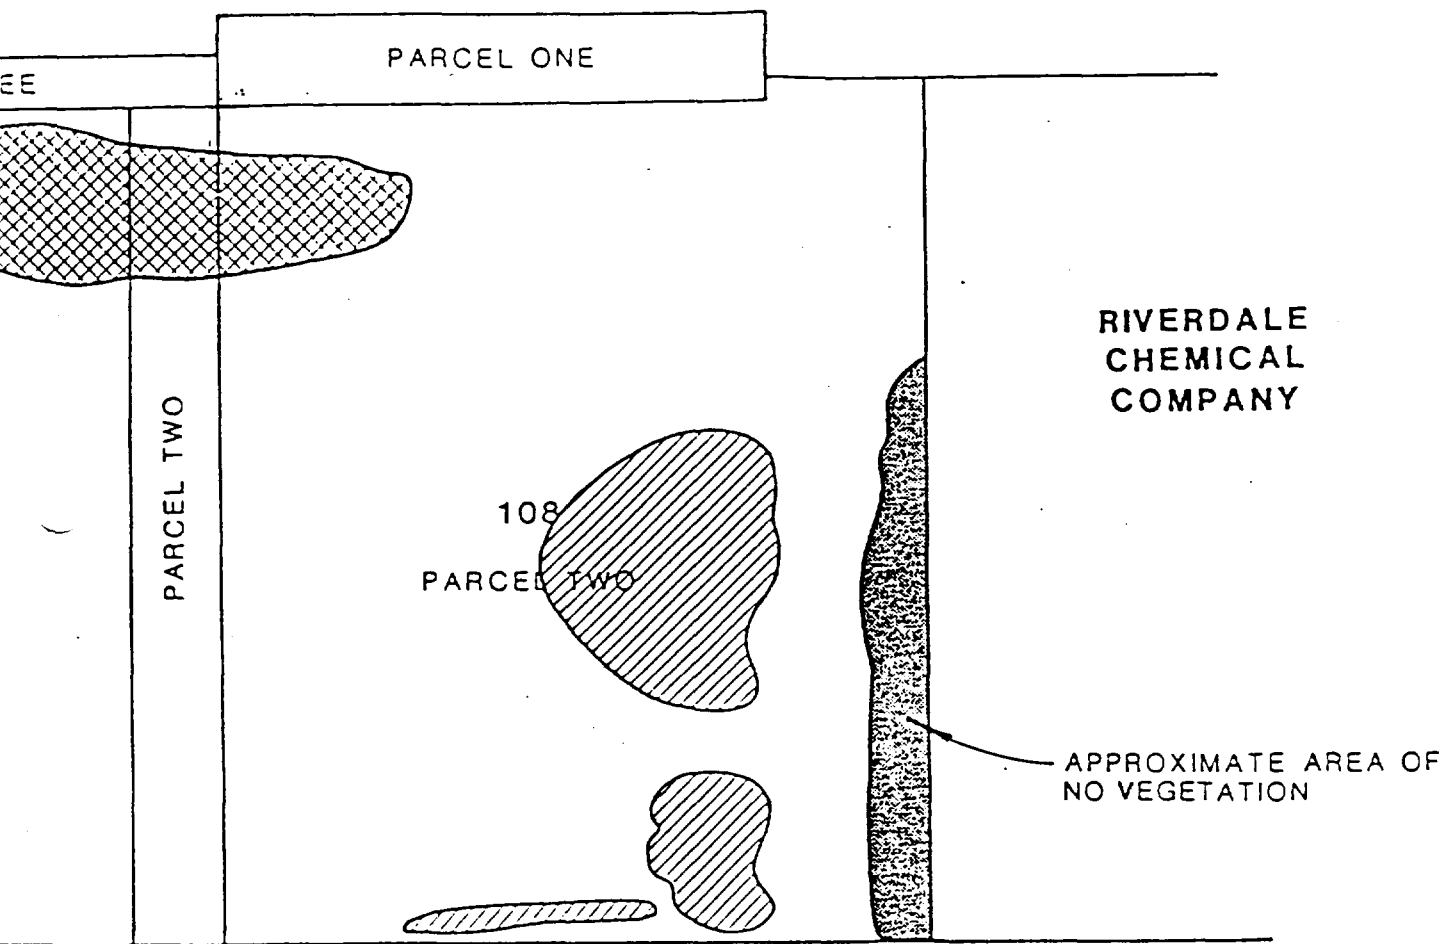
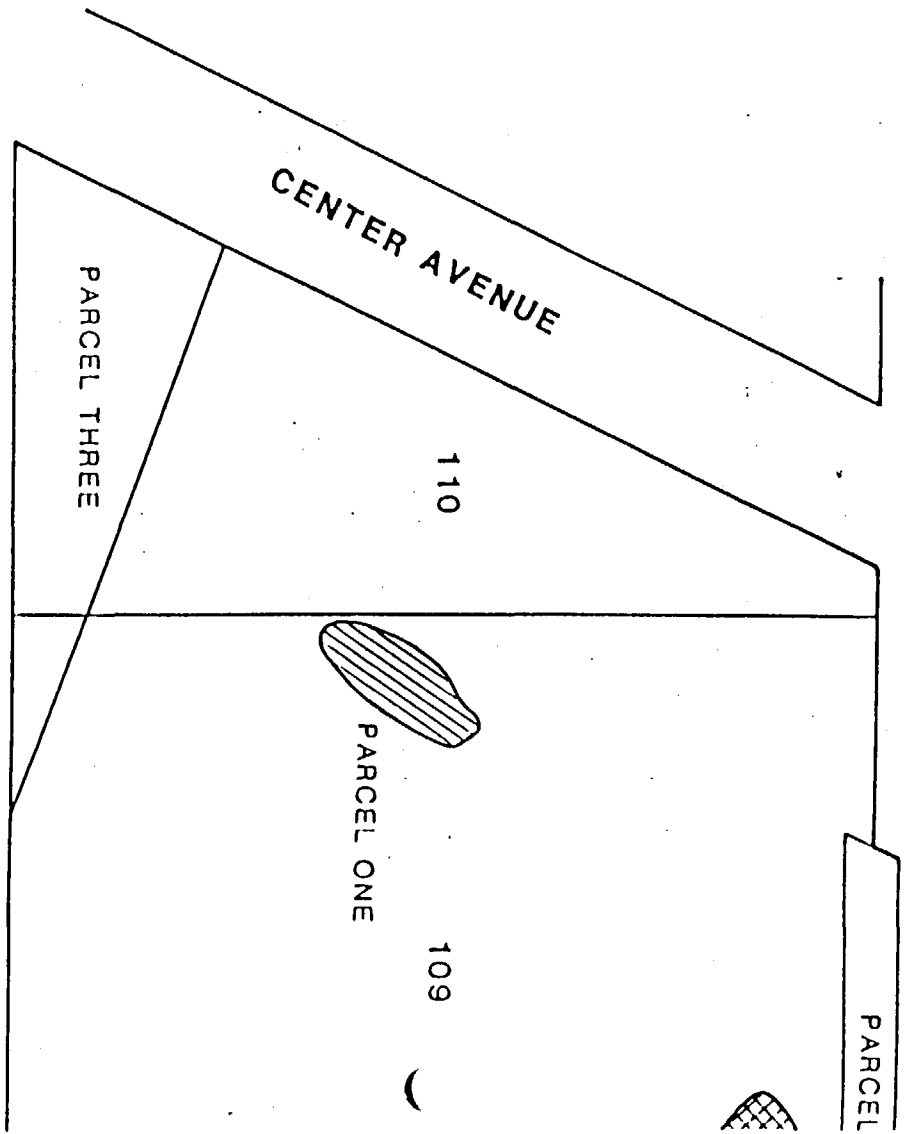
FIGURE 1

The investigation revealed that filling and grading activities had occurred in areas of the site, and several areas of construction debris and household refuse dumping were noted. Foundation remnants of an old building were also noted in the northern portion of Block 108. Figure 1 shows the locations of the above mentioned items.

An area of particular interest was noted along the southeastern edge of Block 108. This area was void of vegetation and extended from approximately 20 feet west of the eastern edge of the Block to the eastern boundary, and from the center of the Block to the southern boundary (Figure 1). The lack of vegetation did not appear to be the result of filling or grading activities.

Based on the analytical results of the soil sampling, it appears that an environmental problem exists in the eastern portion of Block 108, Parcel 2. The visual inspection of this area indicates that the problem appears to be limited to a strip approximately 50 feet immediately adjacent to the eastern edge of the Block, however the actual vertical and horizontal extent of the soil contamination is unknown.

Collection of additional soil samples to determine the vertical and horizontal extent of the problem.

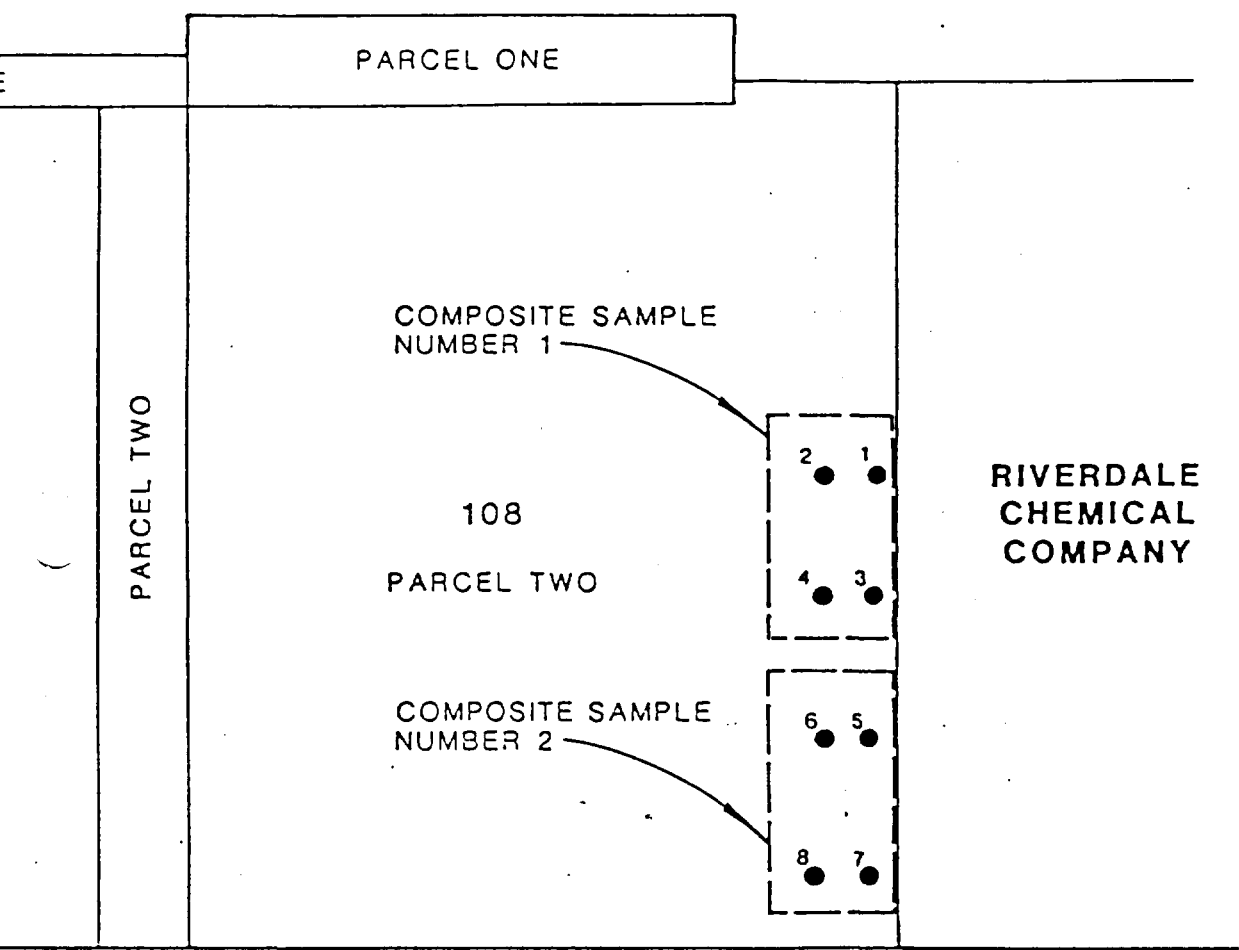
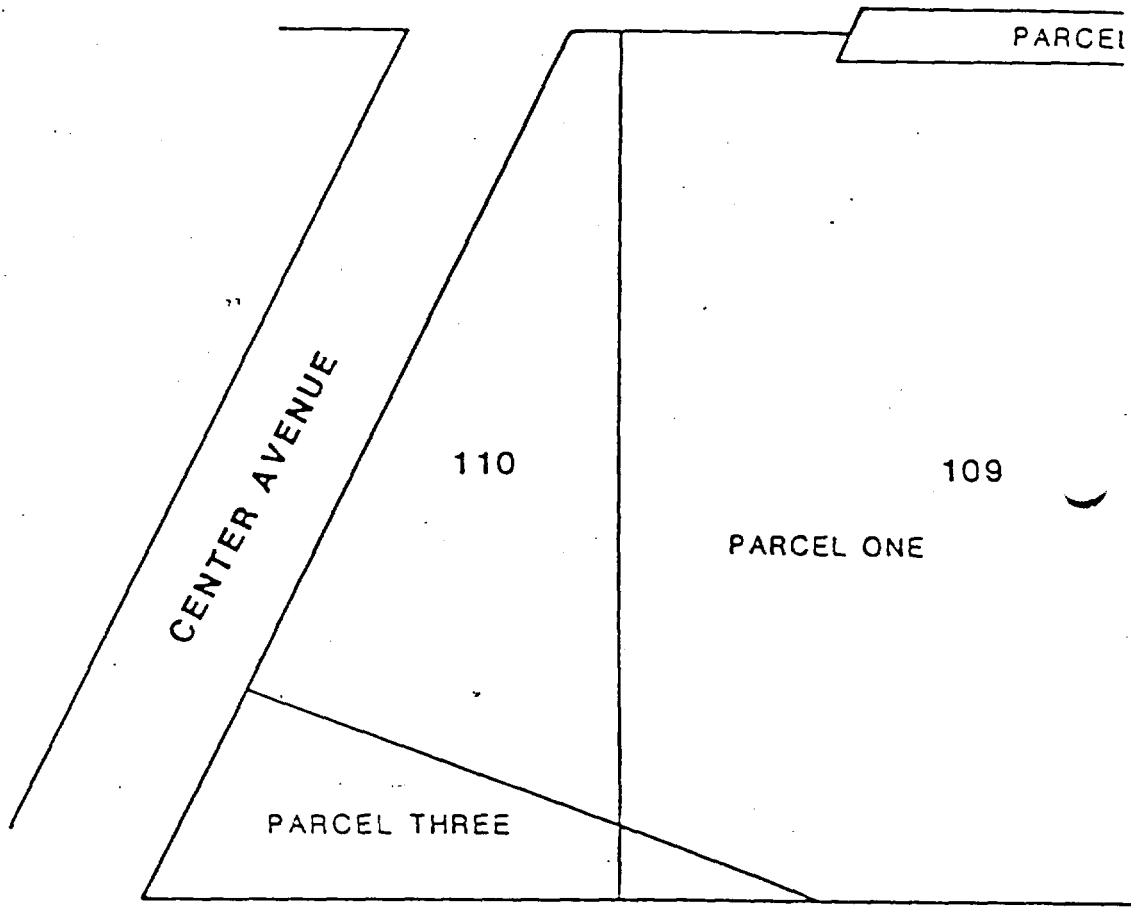
FIGURE 2
SURFACE SOIL
SAMPLING LOCATIONS

Surface soil samples were collected on October 21, 1985. The sampling points were located at equal intervals along two lines located approximately 10 and 35 feet from the Riverdale/CHS property boundary. The sampling locations were marked with a wooden stake indicating the sample number. Figure 2 shows the location of the surface soil sampling points.

Both samples exhibited concentrations of several volatiles, base neutral acid extractables, and pesticides. Analytical sample number 2 exhibited the presence of Dioxin. In general, analytical sample number 2 exhibited higher concentrations of a majority of the compounds detected.
